WIRE STRIKE REPORT

WIRE STRIKE MISHAP ANALYSIS REPORT

Report No. 71-2

**UNITED STATES ARMY BOARD FOR
AVIATION ACCIDENT RESEARCH
Fort Rucker, Alabama**

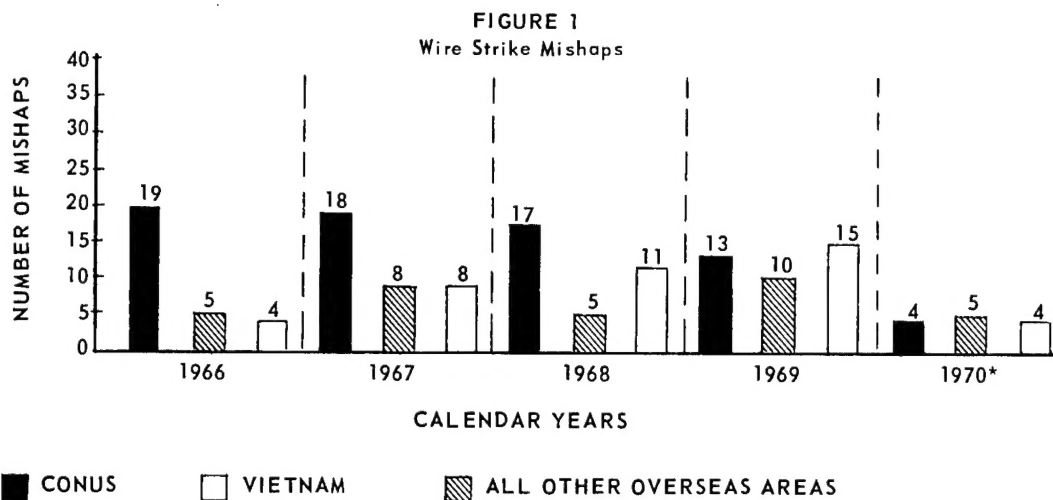
V. DISCUSSION. Figure 1 shows fixed and rotary wing wire strike mishaps by calendar years and location. The 4½ years of data reveals that in-flight collision with wires remained fairly constant, with an average of approximately 32 wire strike mishaps per year. Forty-nine percent of the total wire strikes occurred in CONUS. Vietnam accounted for approximately 29% and other overseas areas (USAREUR, Pacific, Alaska, etc.) reported the remaining 22%. CONUS showed a slight decrease in wire strike mishaps, from 19 in 1966 to 13 in 1969. Vietnam, however, indicated an increase from four in 1966 to 15 in 1969. It is believed the increase in Vietnam mishaps was primarily due to the increase in the flying hour program beginning in CY 1967, the low level mission requirements dictated in the Vietnam operation, and the aviator himself.

Even though figure 1 seems to indicate a decreasing trend for CONUS and an increasing trend for Vietnam, the average wire strike encounters per calendar year for both rotary and fixed wing aircraft remain fairly constant.
